## PROPERTY INSPECTION REPORT

**Concerning:** Hurst, Texas  
(Address or Other Identification of Inspected Property)

**By:** Tom Nguyen TREC #6982 7/24/2006  
(Name and License Number of Inspector) (Date)

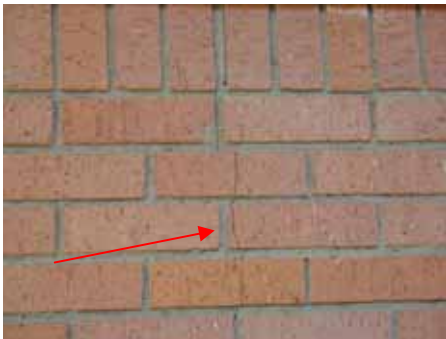
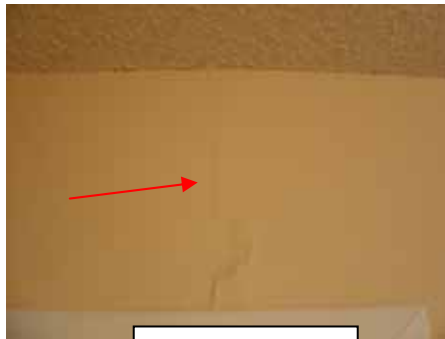
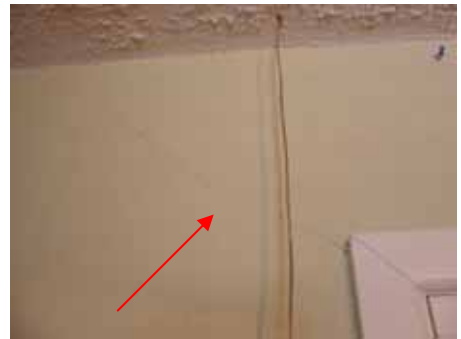
1. Repairs to mortar joints.
2. Outside walls exhibited cracks.
3. Minor to moderate foundation crack found.
4. Inside walls were cracked
5. Ceiling cracks were present.
6. Sloping floors were observed within house at the rear of the house. This implies that some structural movement of the building has occurred.

Wall cracks

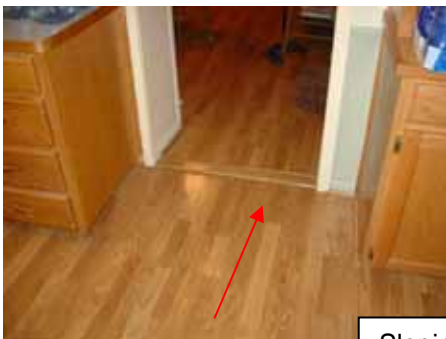
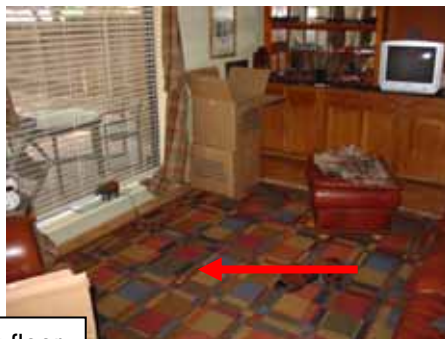
Sloping floor

Floor slopes are apparent at the back of the home. This condition could indicate greater than normal movement within the structure and potential structural problems. Further investigation may be necessary. **In Need of Repair**

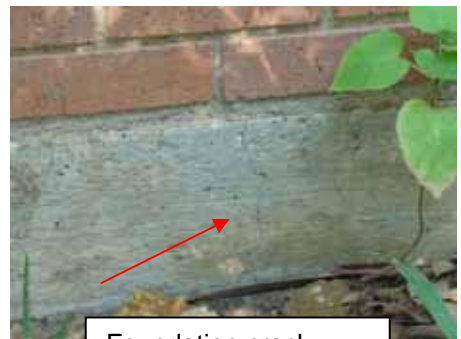
Foundation crack

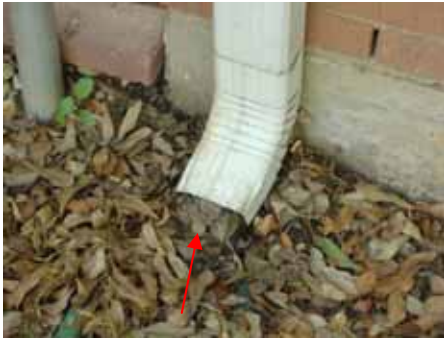
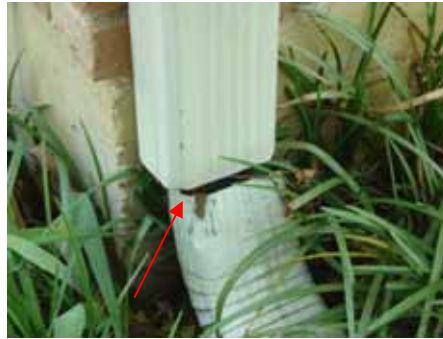
5. Roofing penetrations and wall junctures were flashed utilizing proper techniques.
6. The gutters require cleaning to avoid spilling roof runoff around the building – a potential source of water entry or water damage. **In Need of Repair**

7. The downspout(s) should discharge water at least five (5) feet from the house. Storm water should be encouraged to flow away from the building at the point of discharge. **In Need of Repair**

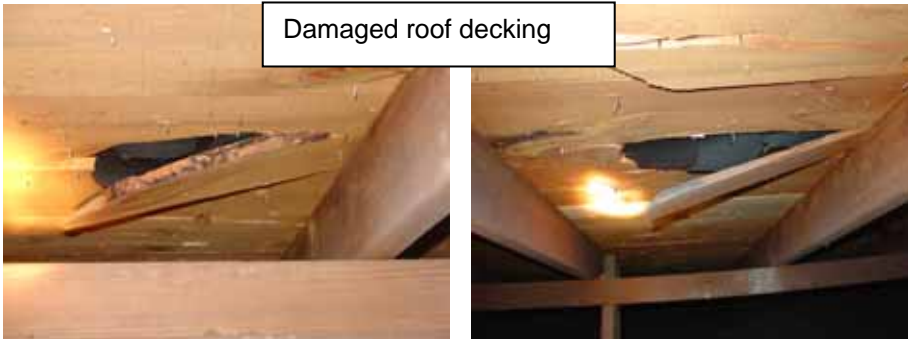
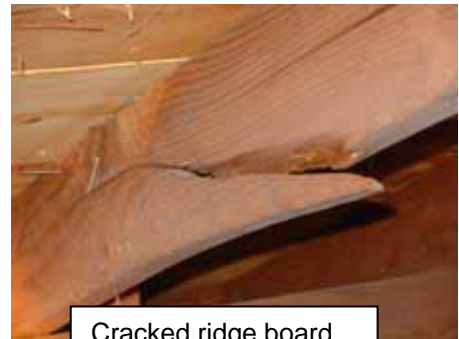
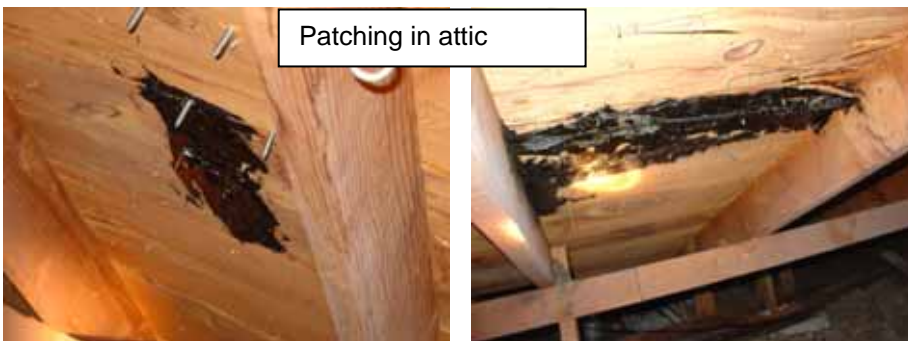
1. Previous signs of water penetration were visible during inspection.
2. The attic was insulated with loose-fill type insulation. The depth averaged 5-8". The recommended depth should be 9-10" inches thick. This recommendation is strictly for information purposes of the buyer for energy conservation considerations.
3. The interior attic inspection did not reveal any issues related to roofing structure.
4. The pull-down ladder was in serviceable condition.
5. The roofing structure appears to be in serviceable condition to effectively support the roof covering.
6. Damaged roof decking should be repaired. **In Need of Repair**
7. Cracked ridge board should be repaired. **In Need of Repair**
8. Patching was noted in the attic. **In Need of Repair**

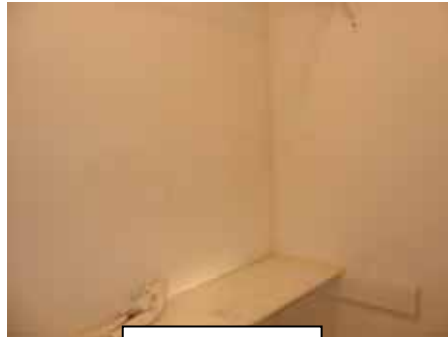
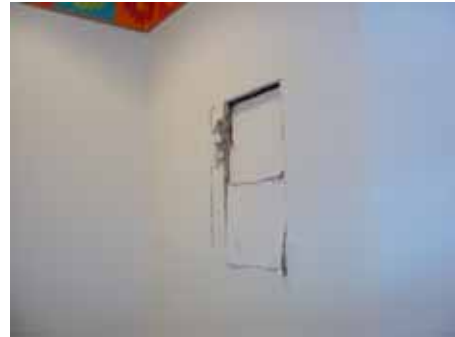
1. Damaged or unfinished drywall was observed in the master bathroom and should be repaired. **In Need of Repair**
2. Water staining was noted in the master bathroom closet. The cause for the staining should be determined and repairs undertaken, if necessary, to prevent structural damage. **In Need of Repair**

Water stain

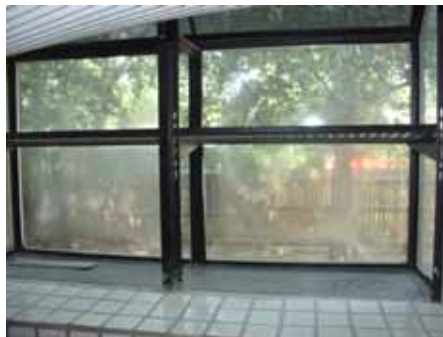
The window(s) in the master bathroom have lost their seal. This has resulted in condensation developing between the panes of glass and can cause the glass to lose its insulating properties. The glass should be repaired or replaced. **In Need of Repair**

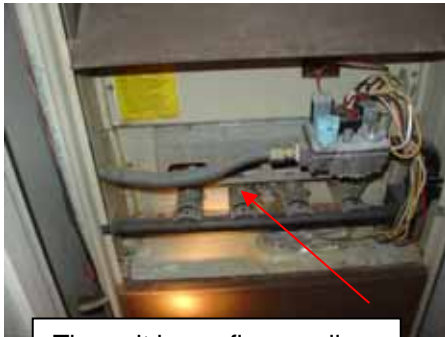
6. This unit requires replacement of the air filter on a regular basis to maintain the air clean and efficiency of operation.
7. The unit has a flex gas line entering the housing of the heater unit. This is a safety issue that should have a rigid line existing the housing, then connecting to the flex line. **In Need of Repair**

The unit has a flex gas line entering the housing of the heater unit.

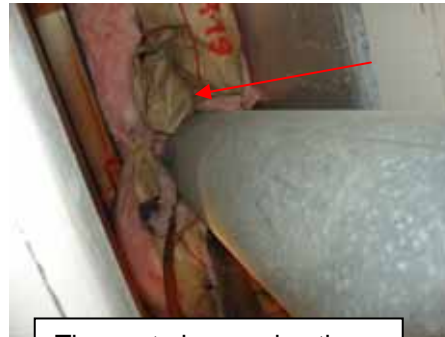
8. The vent pipe serving the heater does not have safe clearance from combustible materials. *This condition should be improved for safety reasons.* **In Need of Repair**

The vent pipe serving the heater does not have safe clearance from combustible materials.

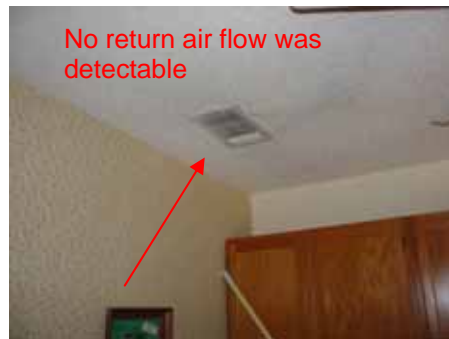
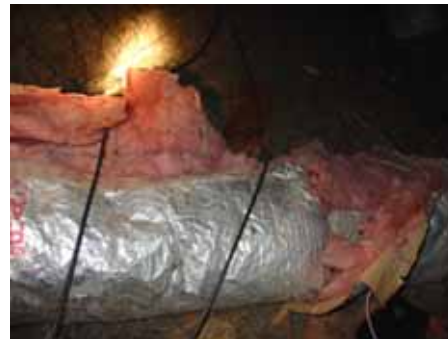
1. Damaged duct insulation in the attic should be repaired. **In Need of Repair**
2. No return air flow was detectable from the vent in the utility room. This would suggest that the return air passageway is obstructed. Repairs should be undertaken. **In Need of Repair**

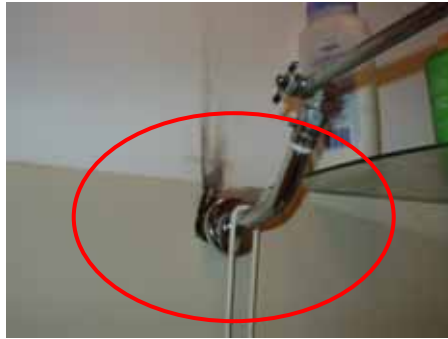
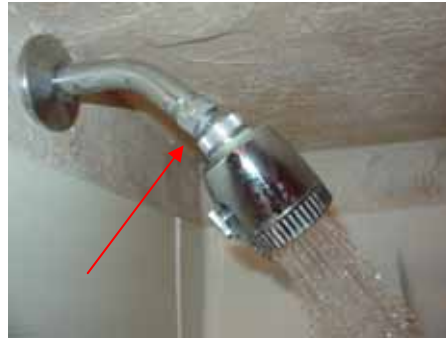
1. The shower head is leaking in the main bathroom and should be repaired. In Need of Repair
2. The drainstop for the sink in the main bathroom is missing and should be repaired. In Need of Repair
3. The shower head in the master bathroom is in poor condition. Replacement may become necessary. In Need of Repair

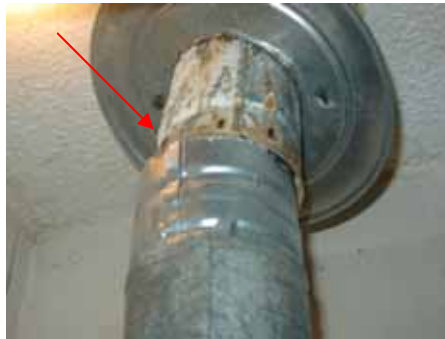
1. The units are 40-gallon capacity water heater located in the attic.
2. The water heater appears to be functioning and to have moderate life expectancy remaining.
3. The pressure relief valve is present and functioning.
4. No water leaks were present at the time of inspection.
5. The pressure relief valve continued to release water at the exterior water drop outside.
6. This unit has a gas and water shut-off valve that is accessible.
7. Inspection of gas lines and fittings was conducted utilizing a Tiff-8800 gas leak detector. No leaks detected.
8. For enhanced safety, it is recommended that the connections of the water heater venting system in the laundry room be improved. **In Need of Repair**
