11012 Kinston Drive, Fort Worth, Texas 76179

PROPERTY INSPECTION REPORT

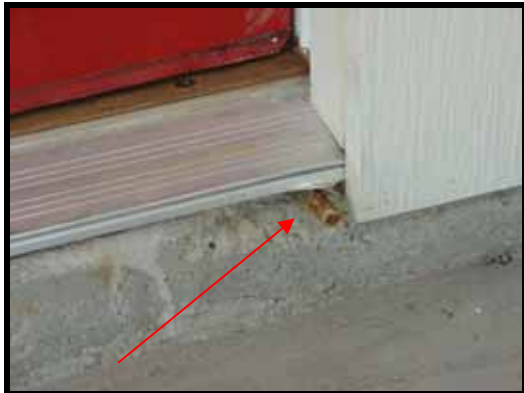
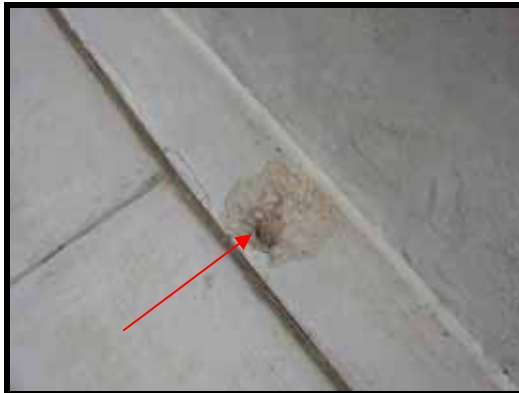
1. Damage to the concrete floor in the garage should be repaired. **In Need of Repair**
2. This home has a slab foundation that has post-tensioned cables to provide strength for the expansive clay soil. The cables are improperly covered by the front door. **In Need of Repair**

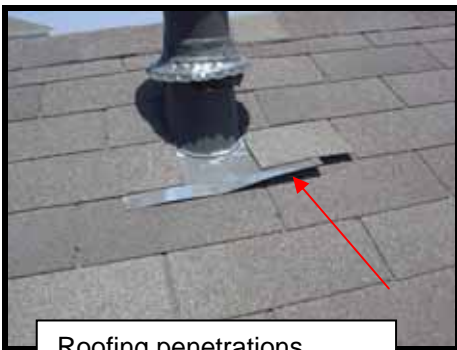
Roofing penetrations should be properly sealed

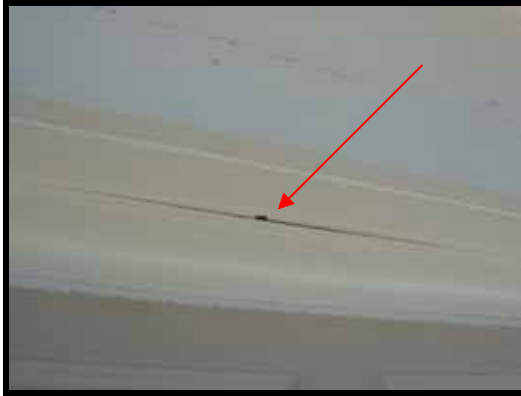
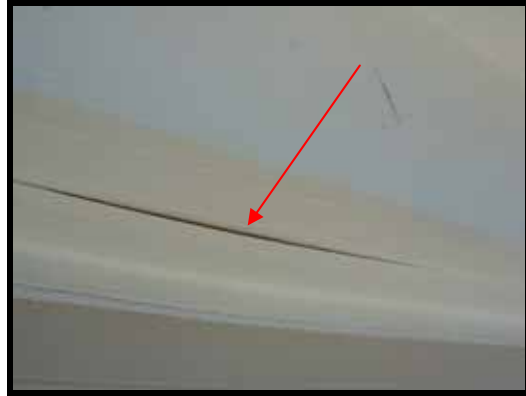
1. Trimming over the garage door are loose and are not properly sealed. **In Need of Repair**

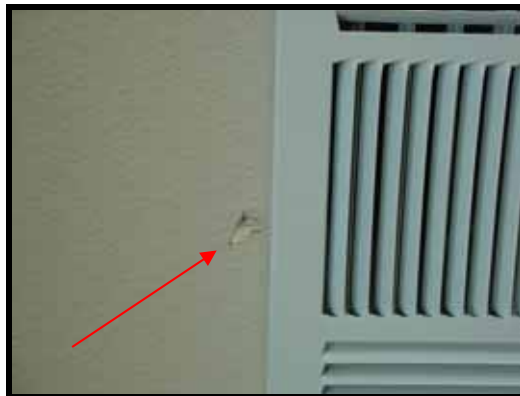
1. Damage to the ceiling was observed in the dining room and should be repaired. **In Need of Repair**

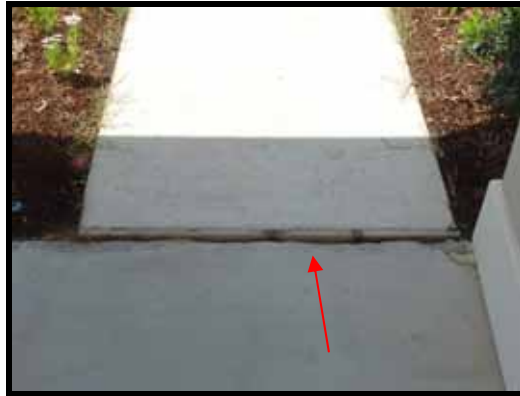
1. The walk way at the front of the house represent a trip hazard and should be repaired. This is a safety concern that should be addressed promptly. **In Need of Repair**

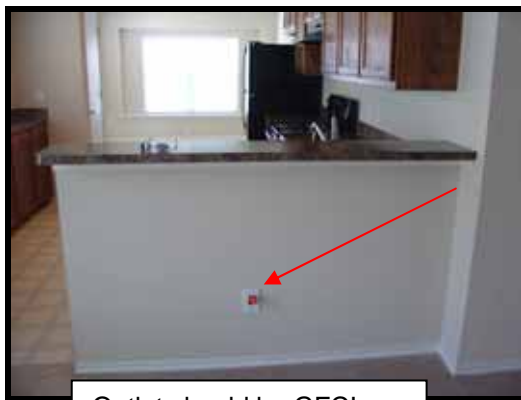
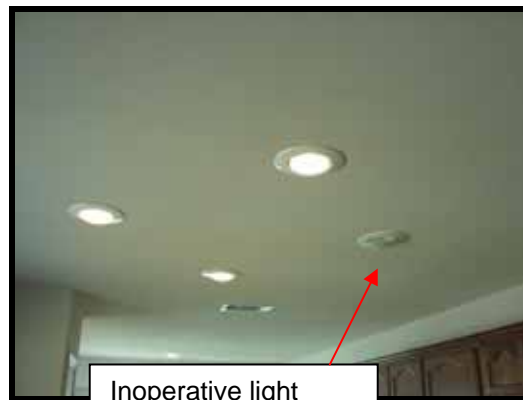
1. The light in the kitchen is inoperative. If the bulbs are not blown, the circuit should be investigated.
2. The installation of a ground fault circuit interrupter (GFCI) on the opposite side of the kitchen sink is recommended. A ground fault circuit interrupter (GFCI) offers protection from shock or electrocution. **In Need of Repair**

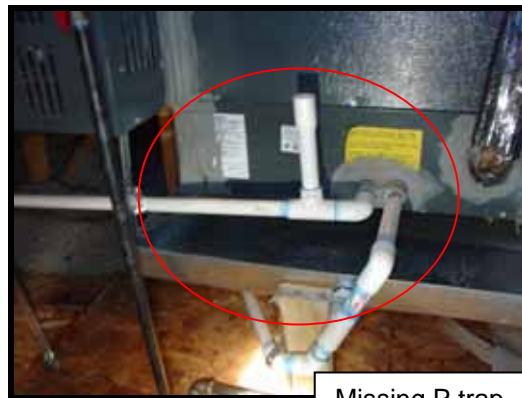
8. The drain pan has debris in it and should be cleaned out. **In Need of Repair**
9. The drain line(s), primary and secondary are properly plumbed.
10. Condensate lines for air conditioning systems that flow into sanitary drains should be "trapped" to avoid the potential for contamination. **In Need of Repair**

Missing P trap

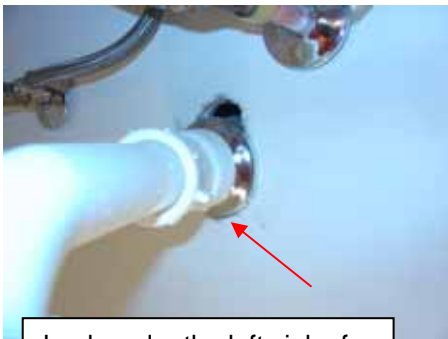
1. There are leaks under all three of the bathroom sinks and should be repaired. **In Need of Repair**
2. It is recommended that an anti-siphon device be added to the hose bib(s) in all locations. **In Need of Repair**

Leak under the left sink of the master bathroom

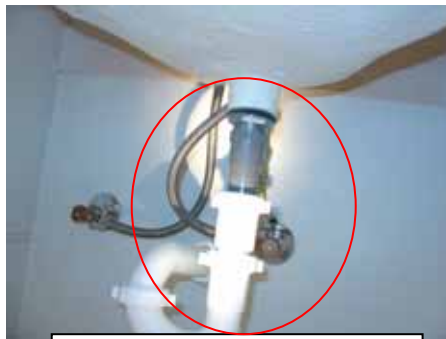
Leak under the right sink of the master bathroom

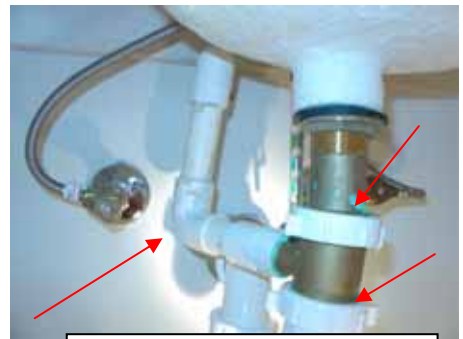
Leak under the sink of the hall bathroom

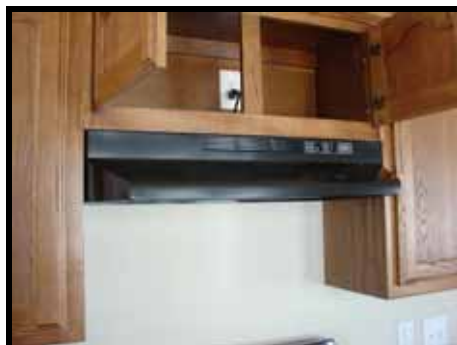
<i>Comments:</i>
 The range hood fan is inoperative and should be repaired or replaced. <u>In Need of Repair</u></p> |

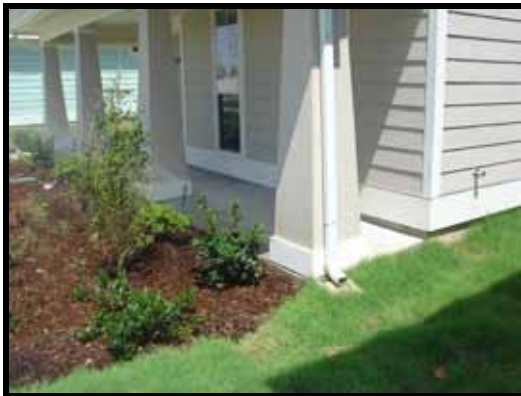
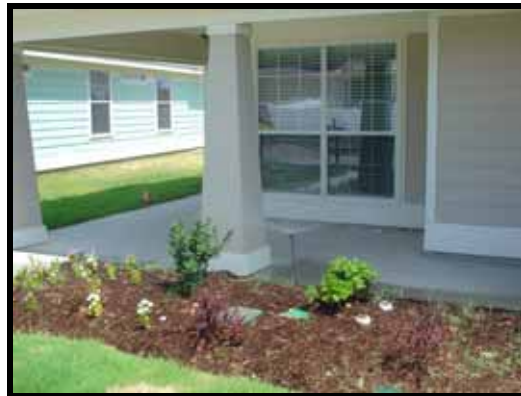
1. The water spray from the sprinkler system should be re-directed away from the structure and/or any fencing, decks, etc., to decrease the possibility of damage. **In Need of Repair**
