11012 Kinston Drive, Fort Worth, Texas 76179

PROPERTY INSPECTION REPORT

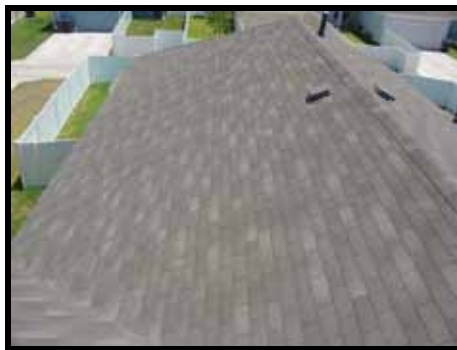
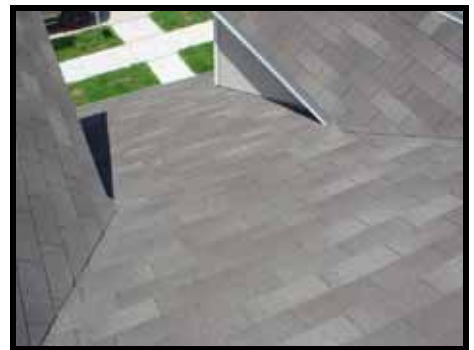
1. The composition-shingle roof covering show no-signs of excessive wear or weathering such as; a concentration of missing composition granules, cracked or split shingles, excessively thin and/or excessive curled edges. This is an indication that the roofing material has full to life expectancy remaining.
2. The roof shingles are uniform in age and wear.
3. The ridge-lines are consistent over the span of the structure.
4. The valleys are properly woven and cut-back.
5. Roofing penetrations should be properly sealed to prevent leaks. **In Need of Repair**

Roofing penetrations should be properly sealed

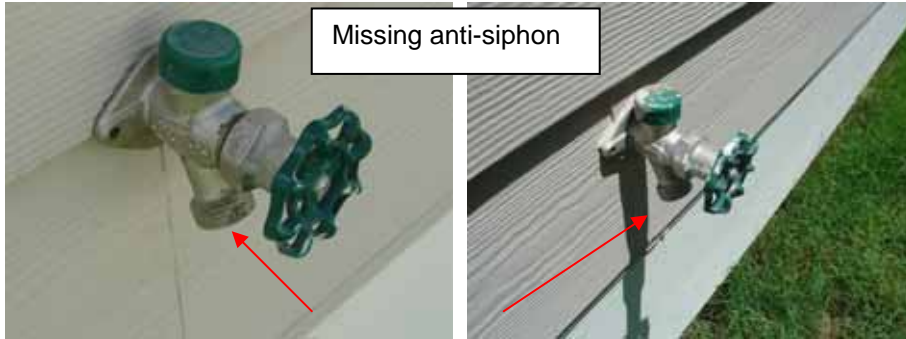
1. There are leaks under all three of the bathroom sinks and should be repaired. **In Need of Repair**
2. It is recommended that an anti-siphon device be added to the hose bib(s) in all locations. **In Need of Repair**

Leak under the left sink of the master bathroom
